737 GRAPHITE COMPOSITE FLIGHT SPOILER FLIGHT SERVICE EVALUATION

THIRD ANNUAL REPORT
APRIL 1976 THROUGH APRIL 1977

1. Report No. NASA CR-145207	2. Government Accession No.	3. Recipient's Catalog No.	
4. Title and Subtitle 737 GRAPHITE COMPOSITE FLIGHT SPOILER FLIGHT SERVICE EVALUATION		5. Report Date August 1977

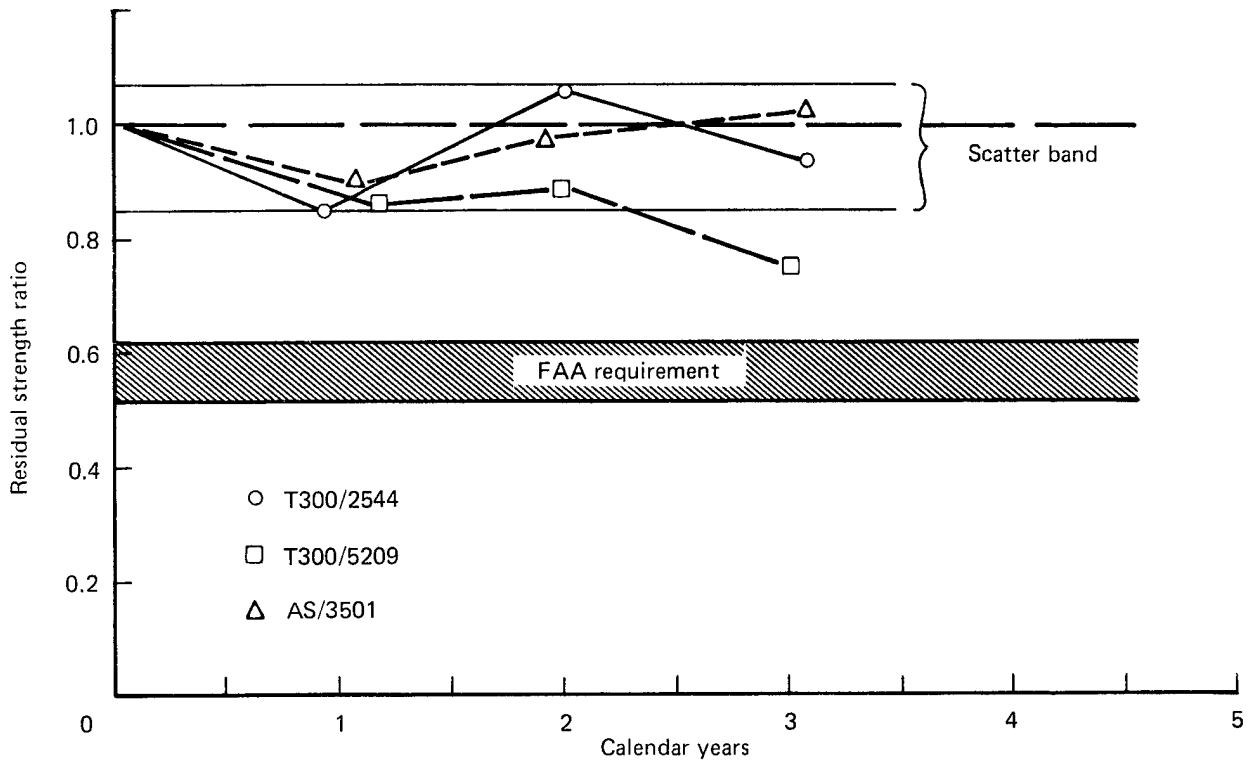
Figure 2. — Residual Strength After Exposure

A plot of the residual static strength data accumulated to date appears in figure 2, and is plotted as a function of time. This data not only continues to point out the scatter in the strength data being collected, but begins to show an identifiable trend relative to both the 250° F curing system and the 350° F curing systems. As shown in figure 2, both 350° F systems are maintaining a relative stability in residual strength as contrasted to the 250° F system.

The scatter band represented by these values is displayed graphically on figure 2. Consideration of this scatter contributes to the previous observation that the 350° F curing systems are maintaining relatively stable residual strength.

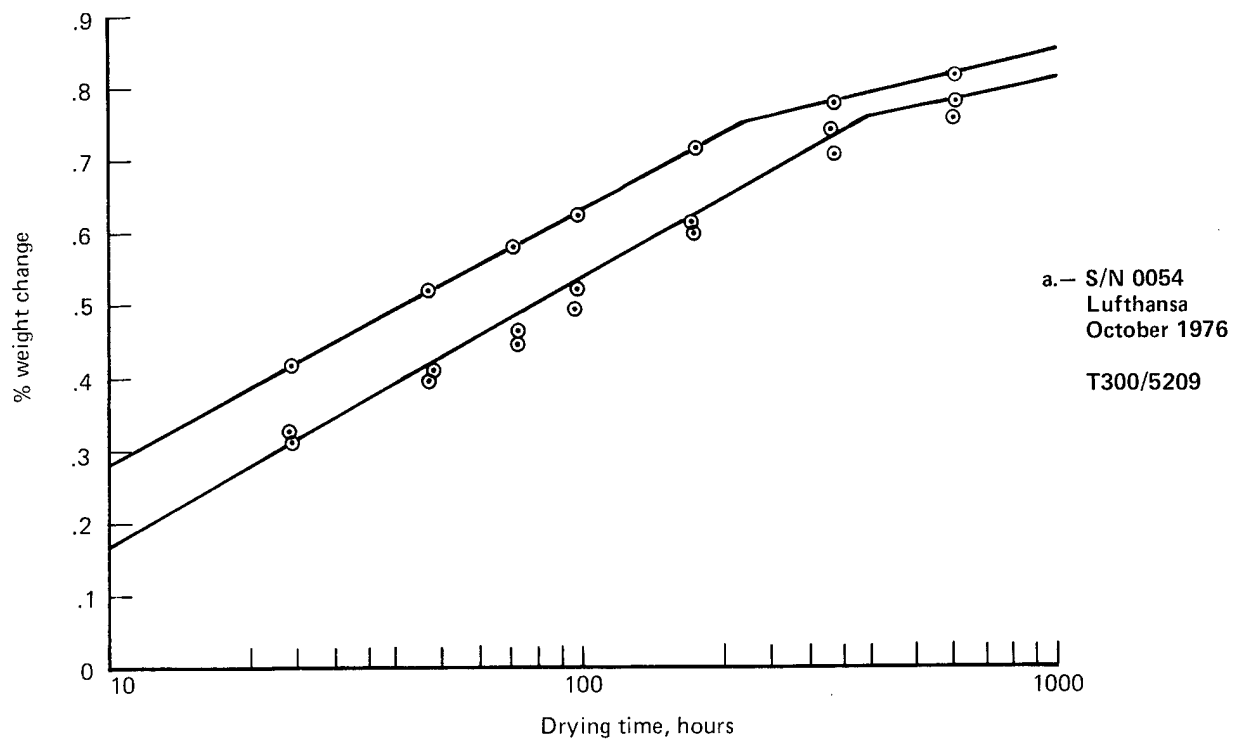
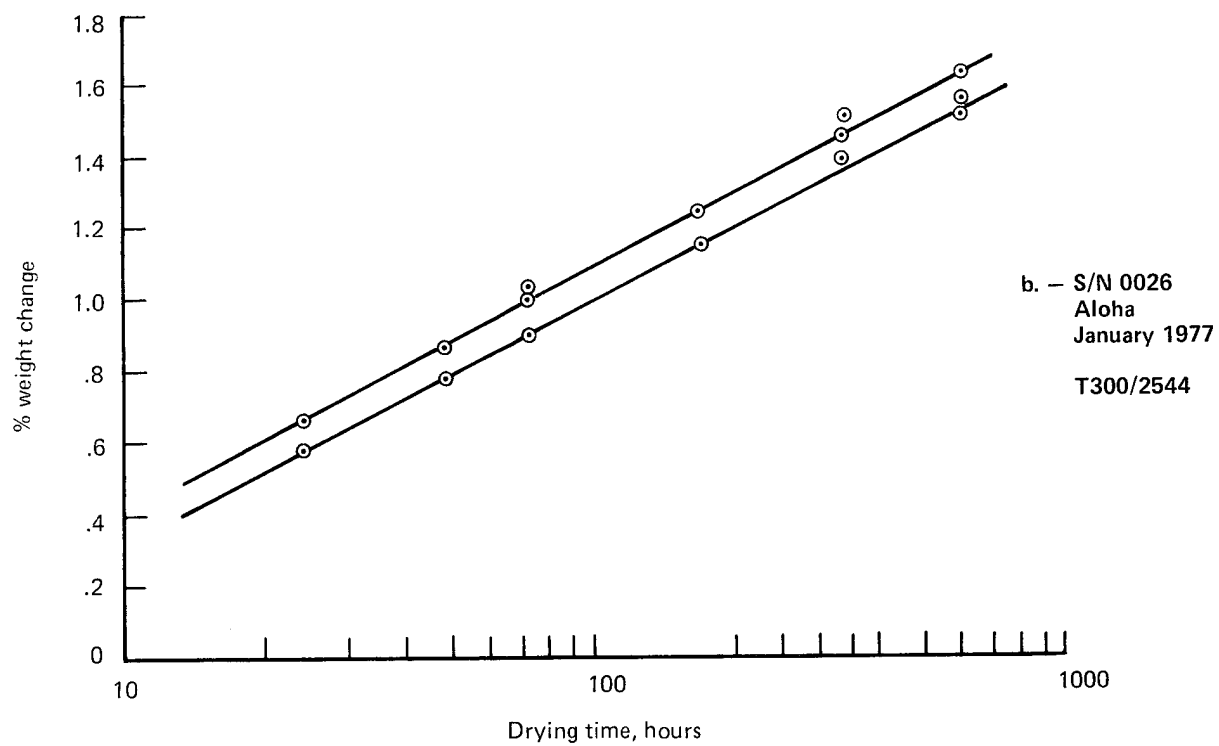
Figure 6. — Moisture Weight Change

The core samples (three per spoiler) are subjected to a 25-day drying environment at 160° F. The samples are weighed at discreet intervals in order to construct the weight-loss curve, an example of which is shown in figure 6. Actual weights of EA9628 adhesive and calculated weights of aluminum core are included in the final values. The final delta weights include moisture absorbed by the laminates and by the two layers of adhesive. Separation of the moisture content in each medium remains to be accomplished.

Two spoiler panels (S/N 0026 and S/N 0054) have been core-sampled prior to static test. The results of drying these samples are given in figure 6. Correlation of the effect of moisture absorption on the residual strength of the spoiler panels remains to be accomplished.

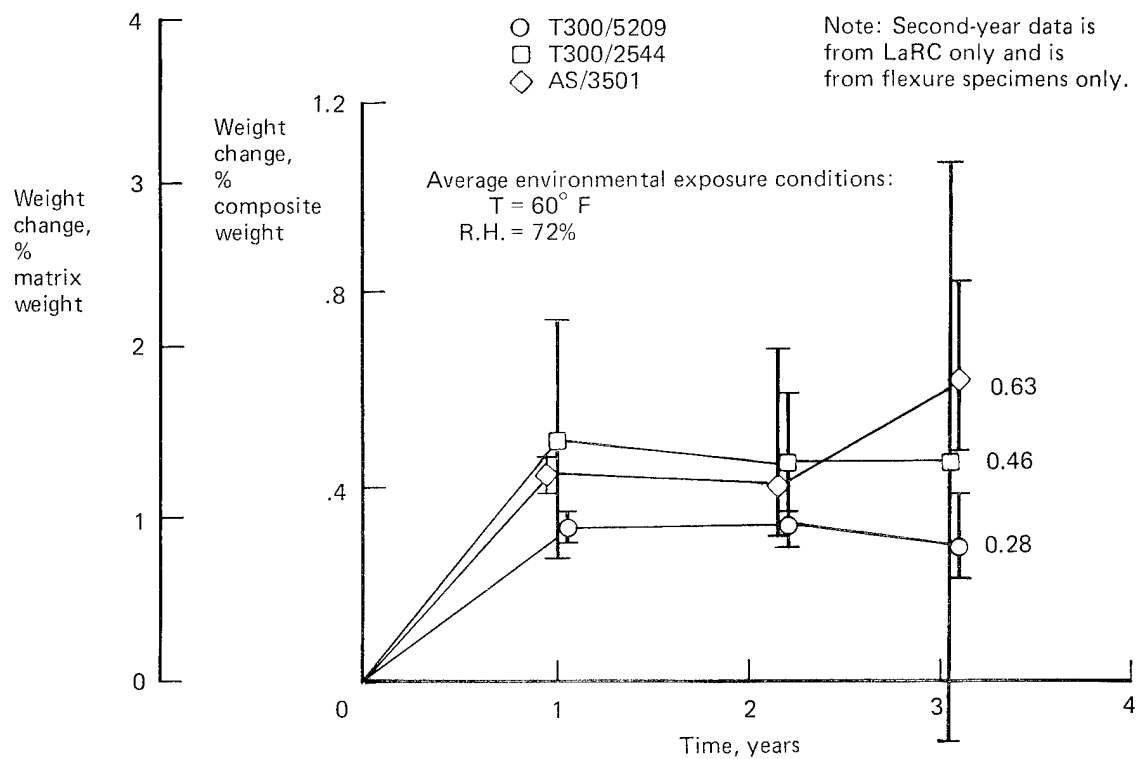
Figure 11. — Moisture Pickup in Exposed Epoxy-Matrix Laminates

Material property specimens were removed from the ground-based environmental exposure program following the third year of exposure. The specimens were returned from the various sites to NASA-Langley for laboratory evaluation. The reduced moisture absorption data has been plotted in figure 11, which also contains the first year data and the "NASA-only" second year moisture data. Current program plans call for a retrieval schedule at the completion of 1, 3, 5, 7 and 10 years of exposure.

The plotted data continued to exhibit a stabilizing trend, with an increasing scatter within the averages. The tabulated moisture data is presented in tables 9, 10, and 11. Plots of strength retention similar to those that appeared in references (1) and (2) are shown in figures 12, 13, and 14. The data for the strength retention plots is also included in tables 9, 10, and 11.
